SITE SELECTION AND EVALUATION REPORT Yakutat Community Health Center Yakutat, Alaska

June 2017 Project Number 428

GEOTECHNICAL ENGINEERING REPORT for the proposed YAKUTAT COMMUNITY HEALTH CLINIC YAKUTAT, ALASKA

Wetland Delineation Report for Yakutat Tlingit Tribe/IHS Joint Project - Yakutat, AK

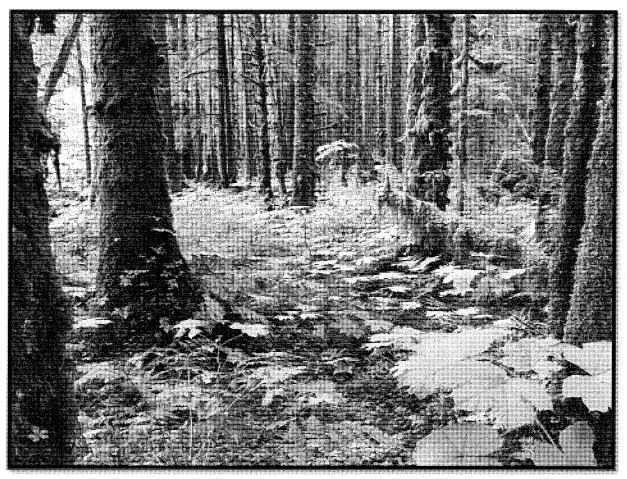
Figure 3 - Typical upland Sitka spruce forest in the project area.

The typical upland vegetation of the project area is a second-growth Sitka spruce - FACU (*Picea sitchensis*) forest with an understory of devils club - FACU (*Oplopanax horridum*), salmonberry -FACU (*Rubus spectabilis*),early and Alaska blueberry - FAC (*Vaccinium ovalifolium and V. alaskaense*), trailing raspberry - FAC (*Rubus pedatus*), spiny wood fern - FACU (*Dryopteris dilatata*), oak fern - FACU (*Gymnocarpium dryopteris*), and dwarf dogwood -FACU (*Cornus canadensis*).
